LEISURE ISLE BOAT CLUB

REPORT ON HARBOUR PILES

JULY 2016

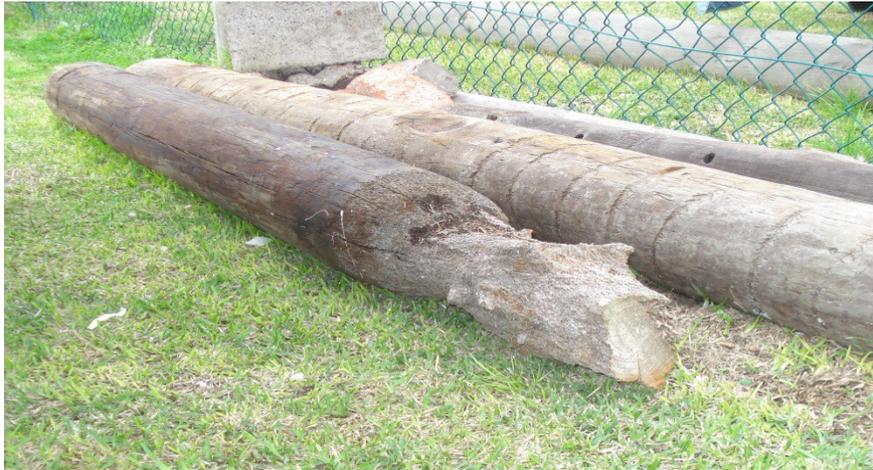
The damage to the affected pile was clearly limited to that section which was above the harbour floor (mud), and below low water mark. The pile was reduced to about 50% of the original diameter and it was obvious that it was very close the end of its usable life. This was of concern, given the fact that it had been in use for only 12-14 years. Since there are over 200 piles in the harbour, the indications were that we were faced with a very high maintenance cost, and it was essential to ensure that whatever action was to be taken should be done in the most cost effective manner possible.

The picture depicts the lower damaged portion of the pole where the diameter has been reduced to approximately 50% of original. Note that the upper section was cut off to facilitate removal of the pole.

It is clear that the damage to the poles is caused by gribble which is the common name used to describe a marine isopod from the family Limnoriidae, of which there are over 50 different species. There is a wealth of information about gribble available on the internet. Pictures of the culprit depict a small animal not unlike a shrimp about 1-2 mm long.

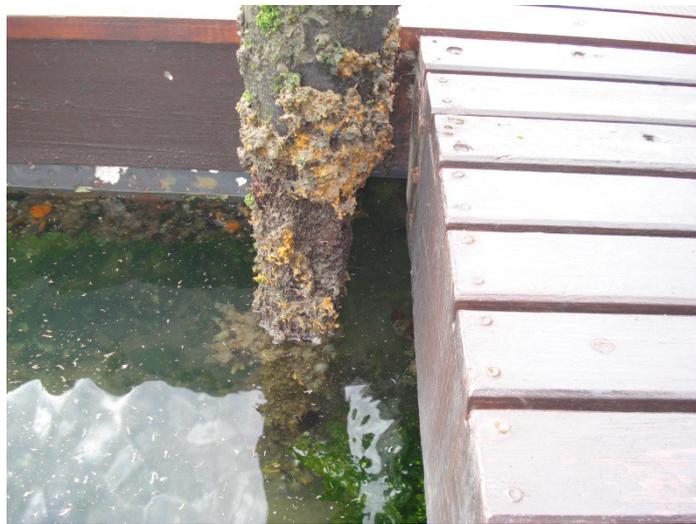
Note: the pile in the worst condition was found to be reduced to about 40% of its original cross section.

This pile was in the worst condition of all piles examined with only about 40% of the original cross section area remaining

- Replace all piles in poor condition over the next 6-9 months – 20 poles
- Replace piles in fair condition over the next 12- 24 months – 110 poles
- Replace all remaining piles within the next 36-48 months.

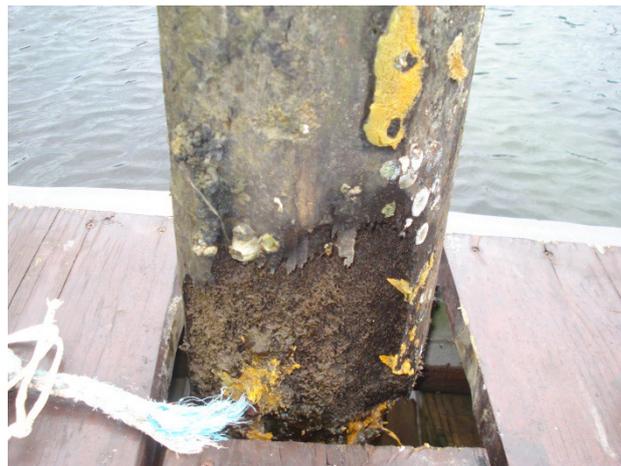
This pile is in a fair condition with about 20-25% damage

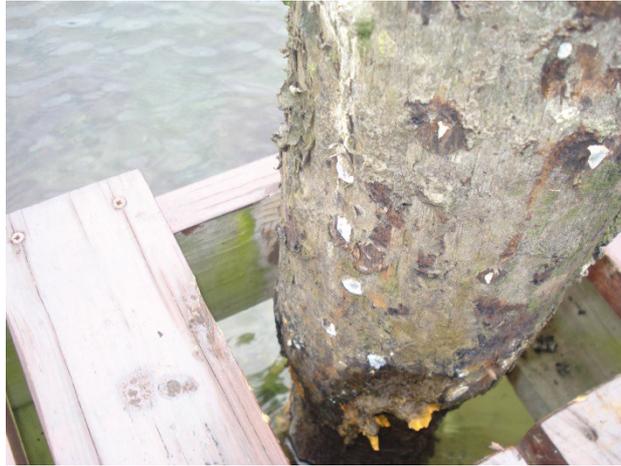
Another pile in fair condition with about 30% damage
