LEISURE ISLE BOAT CLUB

REPORT ON HARBOUR PILES

JULY 2016

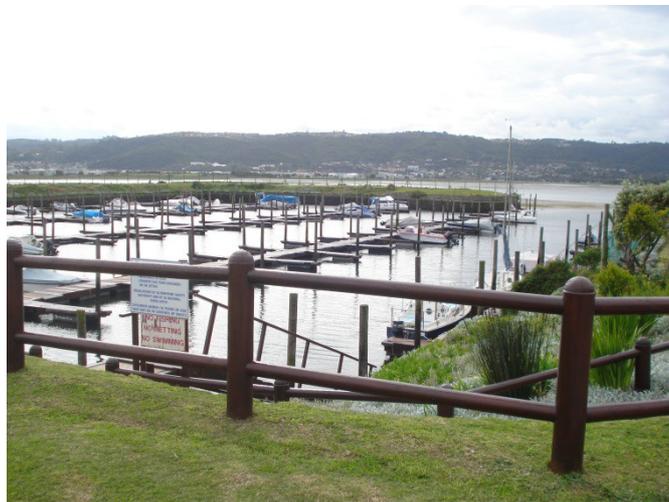
In January this year one of the timber piles (or poles) which support the jetties had to be removed after being dislodged by a boat. Examination of the pile revealed severe attack of the timber caused by marine organisms. Its condition was of concern because it indicated the possibility that LIBC would be faced with the cost of replacing all the piles in the harbour.

The damage to the affected pile was clearly limited to that section which was above the harbour floor (mud), and below low water mark. The pile was reduced to about 50% of the original diameter and it was obvious that it was very close the end of its usable life. This was of concern, given the fact that it had been in use for only 12-14 years. Since there are over 200 piles in the harbour, the indications were that we were faced with a very high maintenance cost, and it was essential to ensure that whatever action was to be taken should be done in the most cost effective manner possible.
